Test report no.: K-K-25-11743

Part*: Alpha Temper 4

Test name: Determination of resistance under UV lamps

Coating characteristics*: roller coating, water-soluble insulating coating for

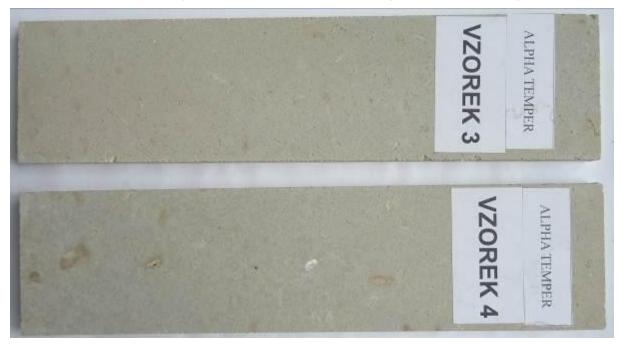
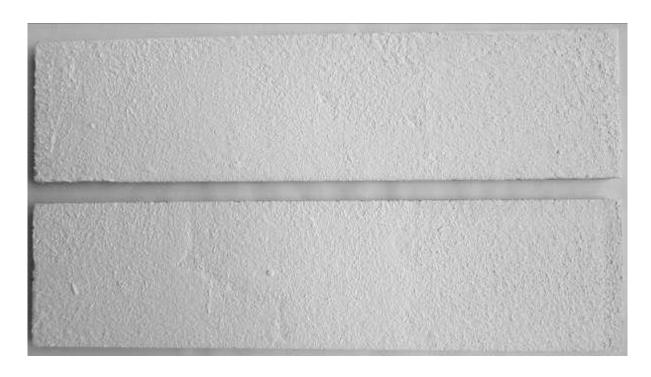
Photos of samples No. 3, 4 500 hours of exposure under UV lamps

Sample	Gloss after 500 h exposure according to ČSN EN ISO 4892-3 [GU]				
Campic	20	60	85		
11743-3	1.2	2.2	0.5		
11743-4	1.2	2.3	0.5

Sample	Deviati 500 hours of exp	Color deviation		
	ΔL	Δа	Δb	ΔΕ
11743-3	0.04	0.01	-0.11	0.12
11743-4	0.05	0.03	-0.06	0.09

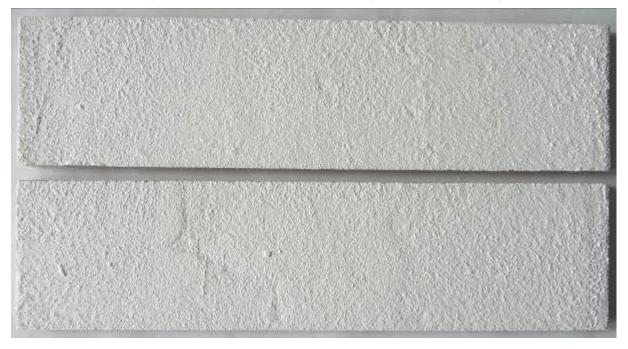
Photo of samples no. 3, 4 1000 hours of exposure under UV lamps

Sample	Gloss after 1000 h exposure according to ČSN EN ISO 4892-3 [GU]			
Gampic	20	60	85	
11743-3	1.2	2.2	0.5	
11743-4	1.2	2.2	0.5

Sample	Deviations in color coordinates after 1000 hours of exposure according to ČSN EN ISO 4892-3			Color deviation
	ΔL	Δа	Δb	ΔΕ
11743-3	-0.38	0.02	-0.12	0.40
11743-4	0.04	0.03	-0.17	0.18

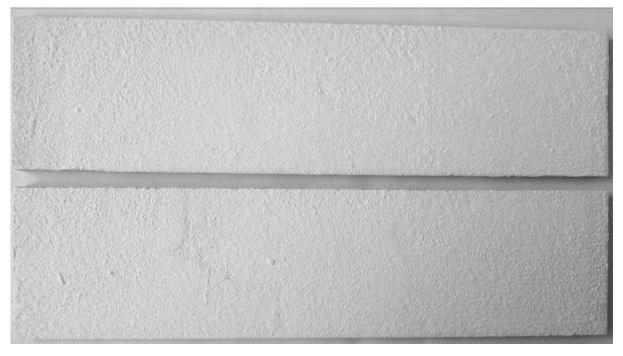
Photos of samples No. 3, 4 exposure for 1500 hours under UV lamps

Sample	Gloss after 1500 hours of exposure according to ČSN EN ISO 4892-3 [GU]			
Gampic	20	60	85	
11743-3	1.2	2.1	0.5	
11743-4	1.2	2.1	0.5

Sample	Deviations of exposure acc	Color deviation		
	ΔL	Δа	Δb	ΔΕ
11743-3	-0.57	0.05	-0.18	0.60
11743-4	0.18	0.03	-0.10	0.21

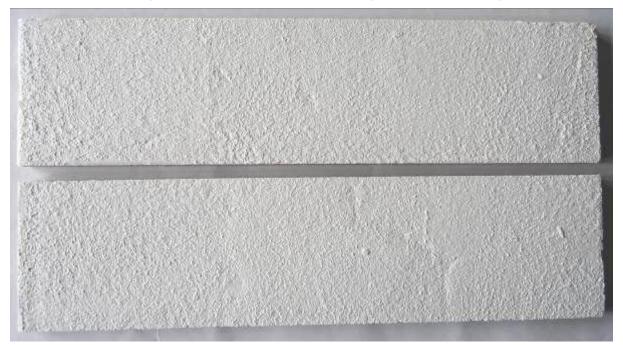
Photo of samples no. 3, 4

2000 hours of exposure under UV lamps

Sample	Gloss after 2000 hours of exposure according to ČSN EN ISO 4892-3 [GU]				
Sample	20	60	85		
11743-3	1.1	2.0	0.5		
11743-4	1.1	2.0	0.5

Sample	Deviations in color coordinates after 2000 hours of exposure according to ČSN EN ISO 4892-3			Color deviation
	ΔL	Δа	Δb	ΔΕ
11743-3	-0.58	0.05	-0.19	0.61
11743-4	0.39	-0.01	-0.10	0.40

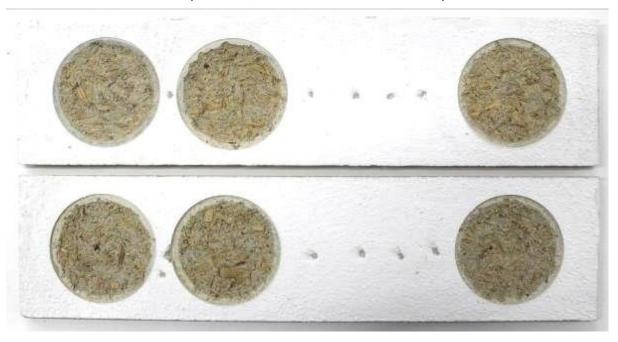
Photo of parts no. 1, 2 after tear test - without exposure

Tear test – reference test samples without exposure, only conditioned under laboratory conditions. Samples 11743-1, 11743-2

Tear strength [MPa]	1.	2.	3.	4.	5.	6.	Average
	0.53	0.61	0.48	0.42	0.48	0.48	0.50 ± 0.06
Character of the quarry	Α	Α	Α	Α	Α	Α	-

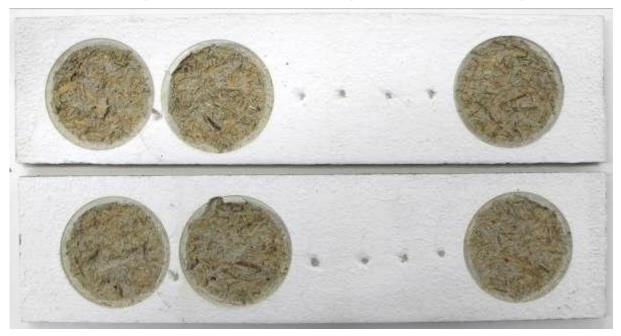
Photo of parts no. 3, 4 after tear test – exposure 2000 h under UV lamps

Tear test – test after 2000 hours of exposure Test according to ČSN EN ISO 4892-3 Samples 11743-3, 11743-4

Tear strength [MPa]	1.	2.	3.	4.	5.	6.	Average
	0.38	0.44	0.39	0.40	0.50	0.43	0.42 ± 0.04
Refractive index	Α	Α	Α	Α	Α	Α	-
