TEMPERATURE RESISTANCE TEST BY WELDING

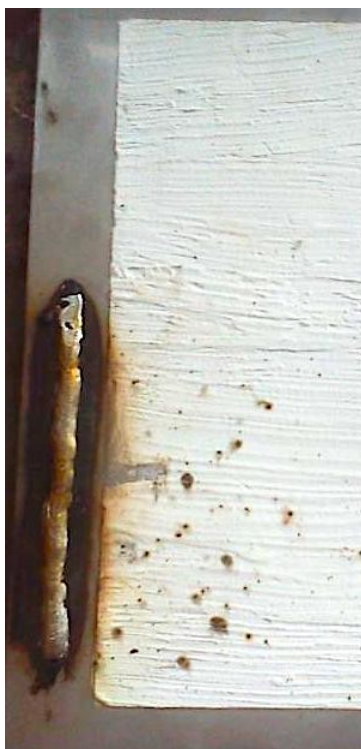
Next to the paint, a welded caterpillar was created. Near the weld caterpillar, a burn of the paint can be observed, it is a band about one to two centimetres from the weld. At this point, the coating peels off, beyond about two centimetres from the weld the coating no longer adheres to the surface and shows no reduction in adhesion.

This test therefore confirms that when welding repairs are required where THRcoating ALPHA TEMPER has been applied, the area can be repainted after welding.
